ENGINEERING MATERIALS REPORT EM-77

DESTRUCTION OF CONCRETE WATER TANKS IN A SEVERE CLIMATE DUE TO ICE LENSING

BY
CHRISTOPHER ROGERS
AND
BOGUSLAW CHOJNACKI

ONTARIO
MINISTRY OF TRANSPORTATION AND COMMUNICATIONS
ENGINEERING MATERIALS OFFICE
SOILS AND AGGREGATES SECTION
OCTOBER, 1986

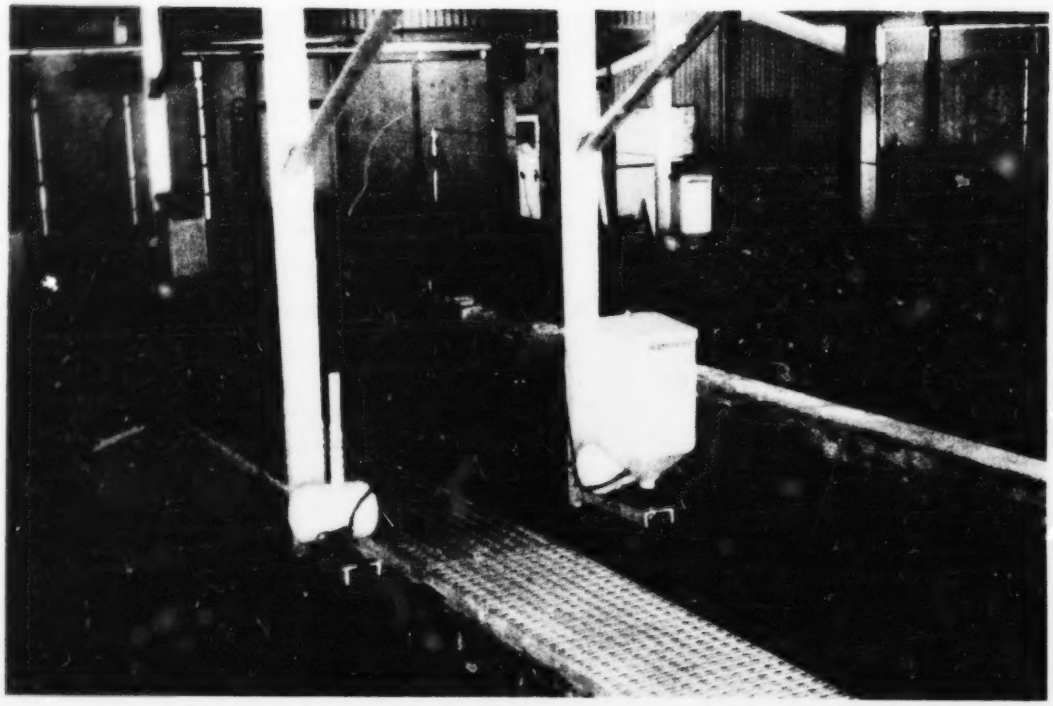
Generally, the tops of the tank walls only projected 300 mm above the surrounding concrete floor. The exterior wall of one tank (No. 6) projected 1.2 m above the surrounding concrete walkway. Most tanks shared a common adjoining wall (Figure 1). The tanks were under a high roof. The north side of the building had a plywood wall, the west and east walls had a partial wall and the south side was completely open.

FIGURE 1: GENERAL VIEW OF FISH TANKS

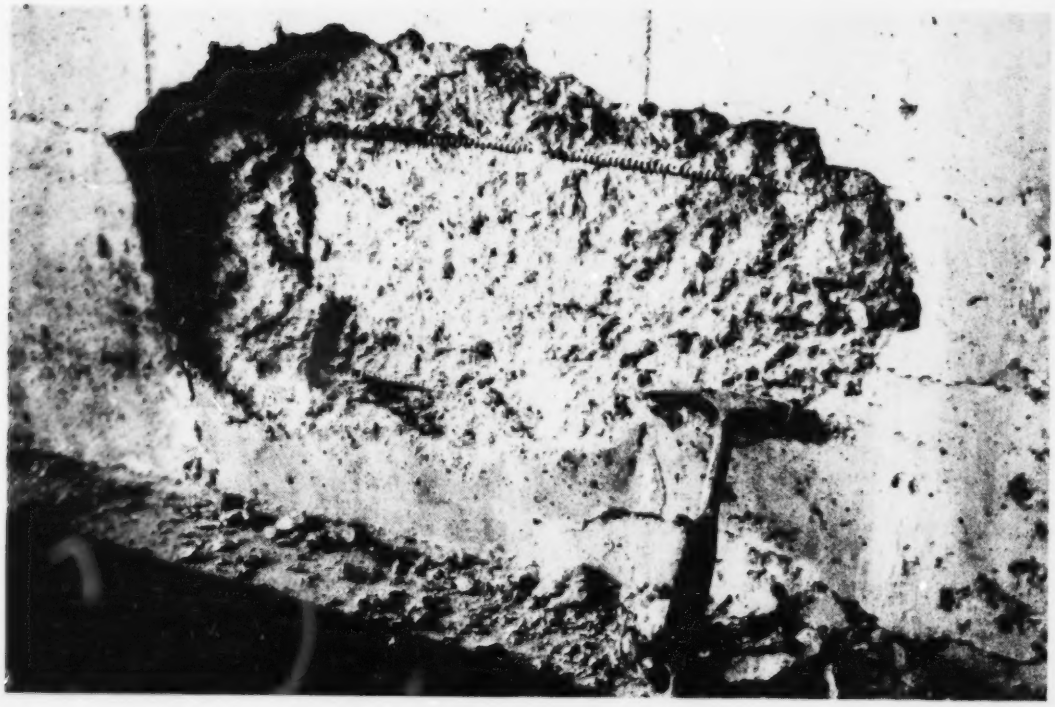
During the first winter, the exterior concrete wall of tank 6 failed. The wall cracked and delaminated in a local area so that water leaked at such a rate that it became unusable (Figure 2). As a result of this failure and associated damage to some other tanks (Figure 3), the whole facility was closed.

Of the ten tanks, only exterior wall of tank 6 had failed (Figure 2). The concrete had failed locally in an area of 0.4 m^2 (4 ft^2), just above the floor of the tank. There was delamination and cracking, parallel with the surface, at a depth of between 40-80 mm (1 $^1/_2$- 3 inches). The reinforcing steel, which was uncorroded, was exposed. The top of the common wall between tanks 6 and 7 also showed severe deterioration, but had not failed (Figure 3). Concrete to a depth of 100 mm (4 inches) had delaminated and lost all strength. A 4 mm wide crack on an otherwise undamaged upper surface of part of this wall was partly filled with a white, crystalline powder, which on subsequent testing was found to be Trona (sodium carbonate), Figure 4.

FIGURE 2: FAILED AREA IN WALL OF TANK 6

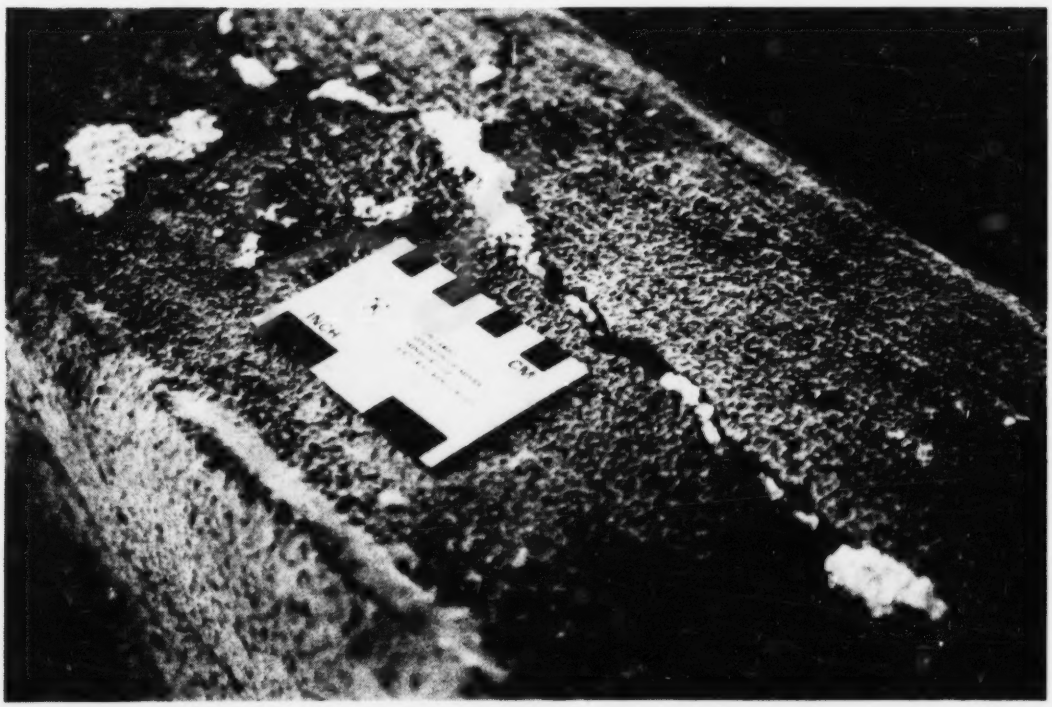
FIGURE 4: CRACK FILLED WITH SODIUM CARBONATE, IN WALL BETWEEN TANKS 6 AND 7

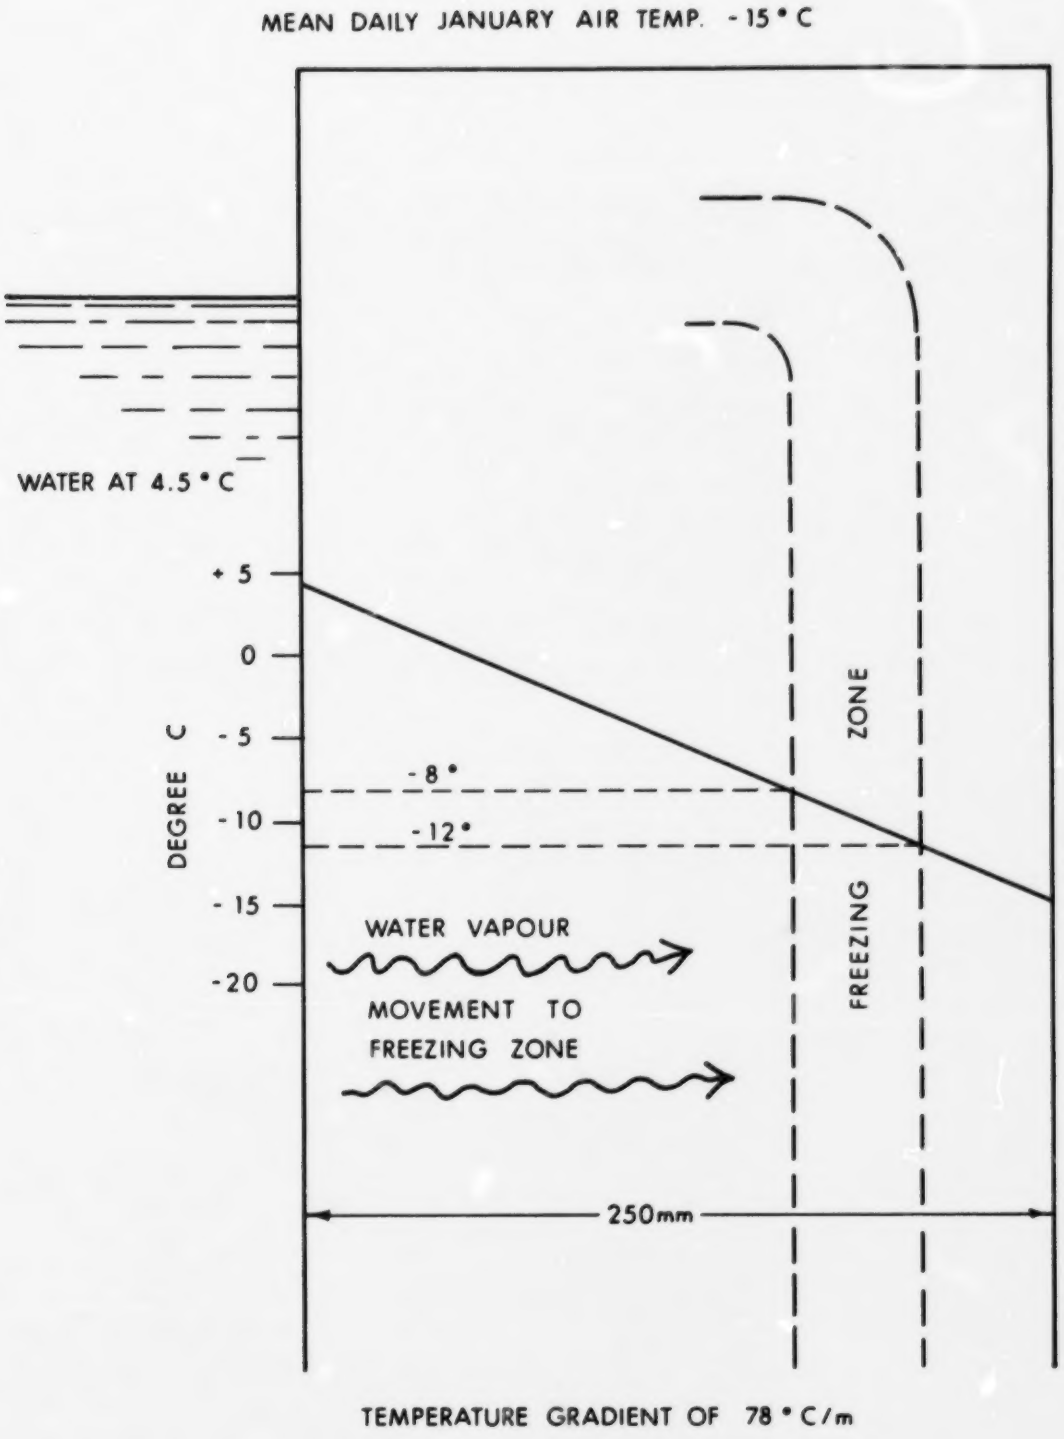
Figure 5 shows this system diagramatically. The zone of ice formation, assuming this temperature gradient, should have been at a depth of 45-85 mm behind the outside surface. This corresponds approximately with the position of fractures found within the concrete walls (Figure 2, 6 and 7).

FIGURE 5: TEMPERATURE GRADIENT AND FREEZING ZONE IN CONCRETE WALL

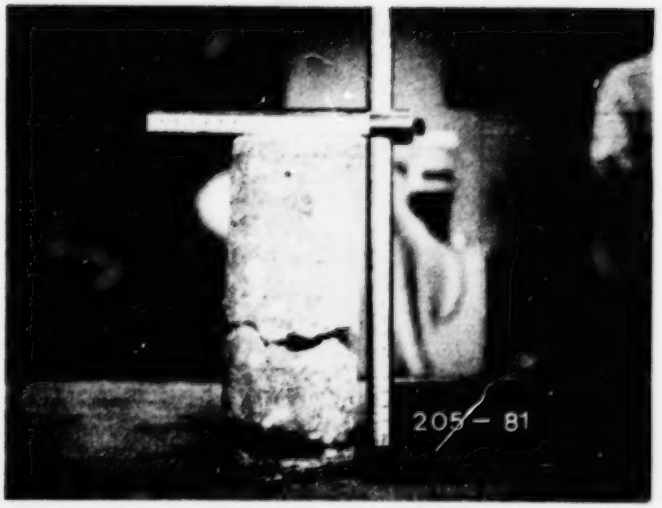
It is significant that those areas which failed (represented by samples 4, 7, 20, 21 and 22) had the poorest quality concrete. The water absorption was above average and the air content was below average compared with the average of all the samples (Table 1). After failure occurred, the tanks were drained and the severe conditions ceased to exist. The concrete of poorest quality failed first, the slightly better quality concrete may have failed given sufficient time.

FIGURE 6: SAMPLE 4, FROM WALL OF TANK 6

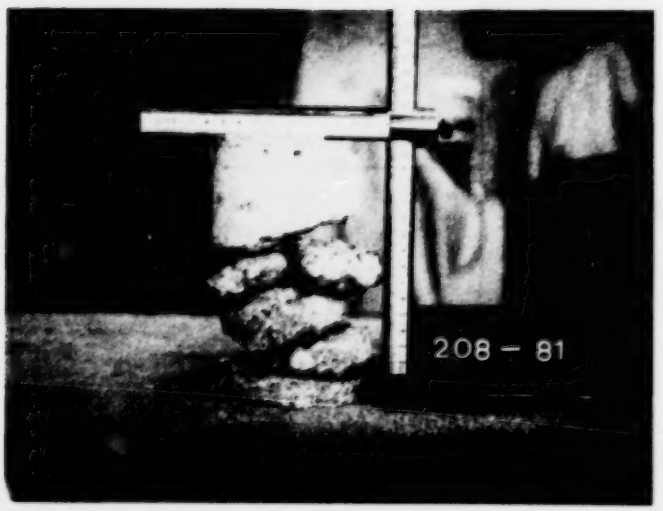
FIGURE 7: SAMPLE 7, FROM WALL OF TANK 6
